PARKLANDS LEE

BOARD OF SUPERVISORS REGULAR MEETING AGENDA

STORMWATER PIPE OBSERVATION REPORT

LAKE BANK OBSERVATION AND RESTORATION REPORT

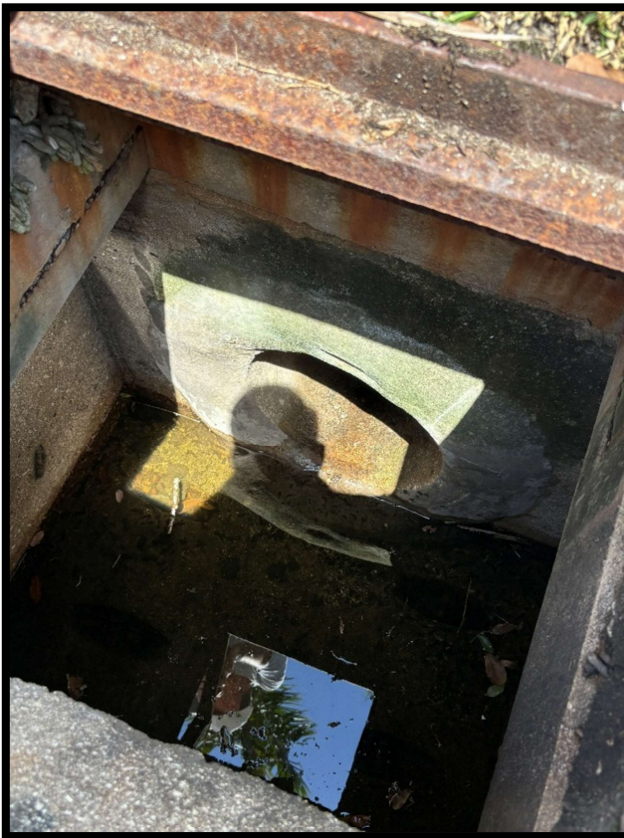
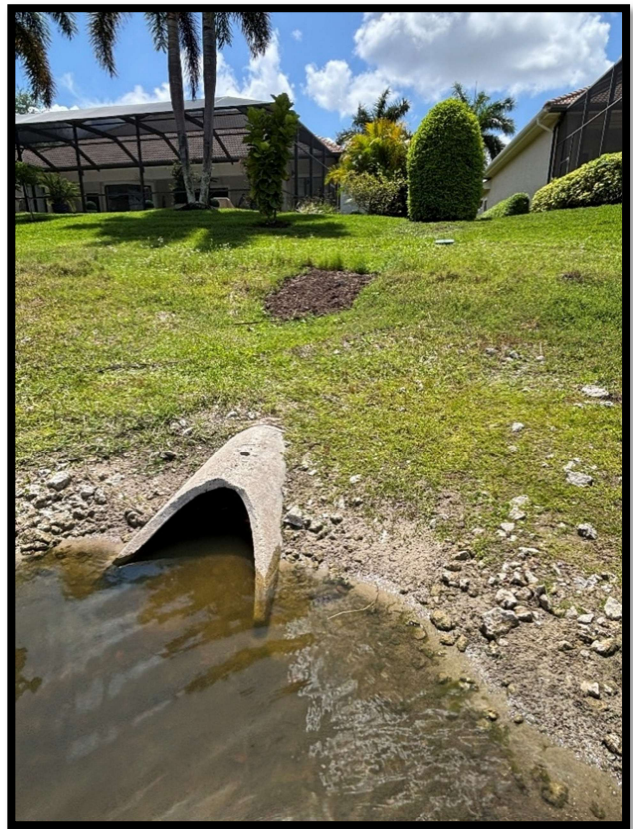
- The inlet box contains standing water at the bottom.
- The pipe opening is visible from the inlet, confirming connectivity to lake
- No debris accumulation or blockage observed at the waterline.
- Pipe outlet at shoreline is visible; stable conditions; and no erosion observed.

- 4 feet from bottom of box to top of box.

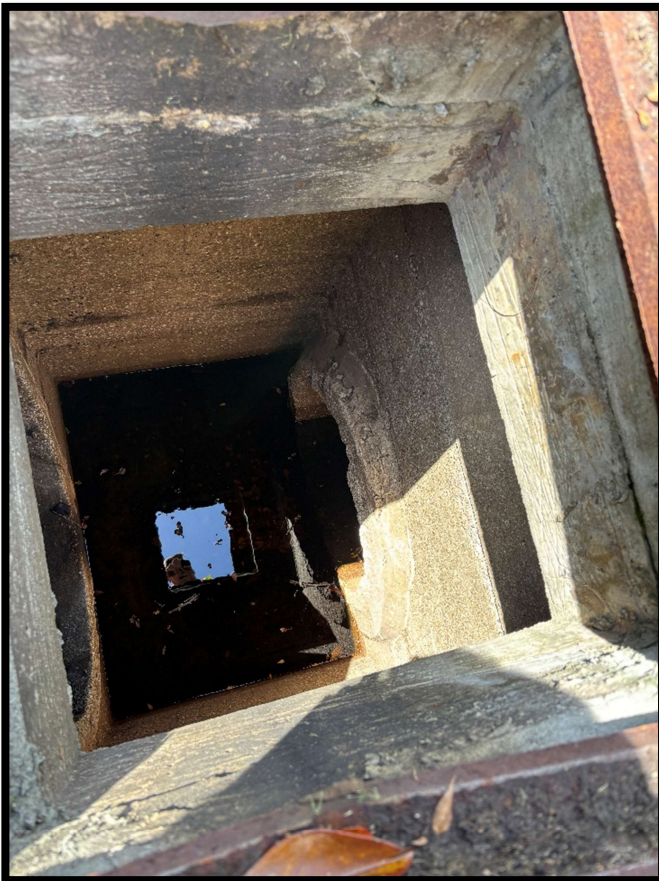
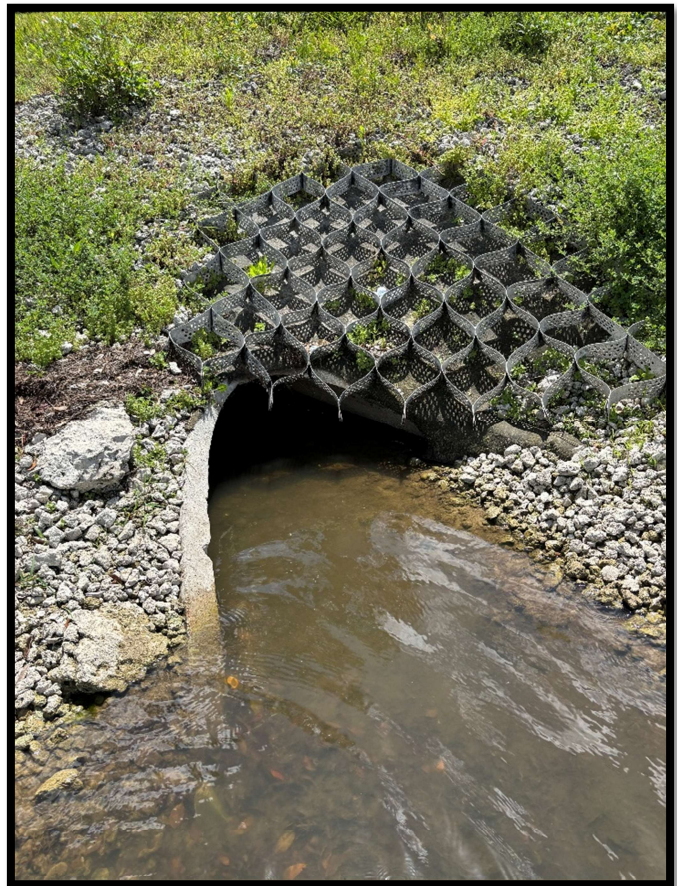
PHOTOS OF PIPE INLET 35 AND OUTLET 36 (LAKE 2L)

- The inlet box contains standing water at the bottom.
- The pipe opening is visible from the inlet, confirming connectivity to lake
- No debris accumulation or blockage observed at the waterline.
- Pipe outlet at shoreline is visible; stable conditions; and no erosion observed.

- 8 feet from bottom of box to top of grate.

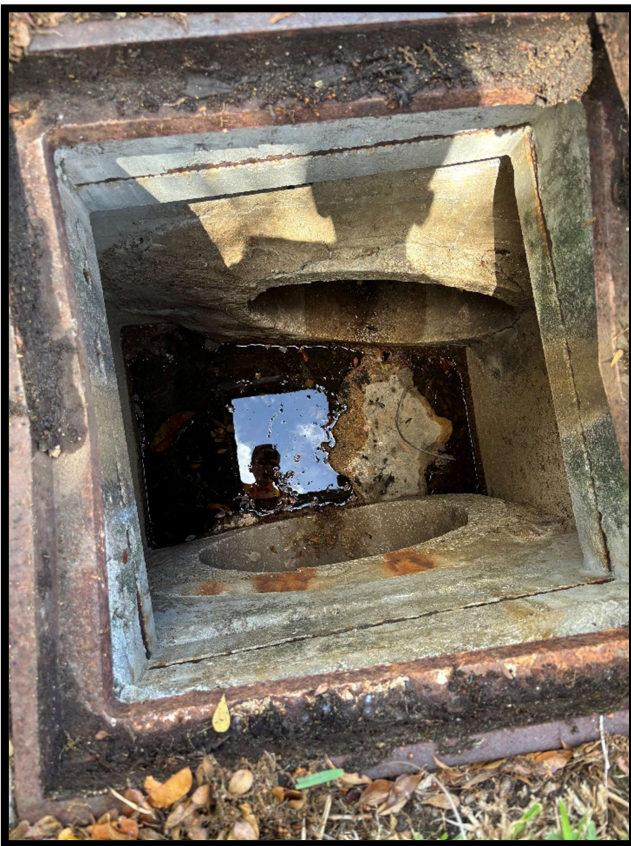
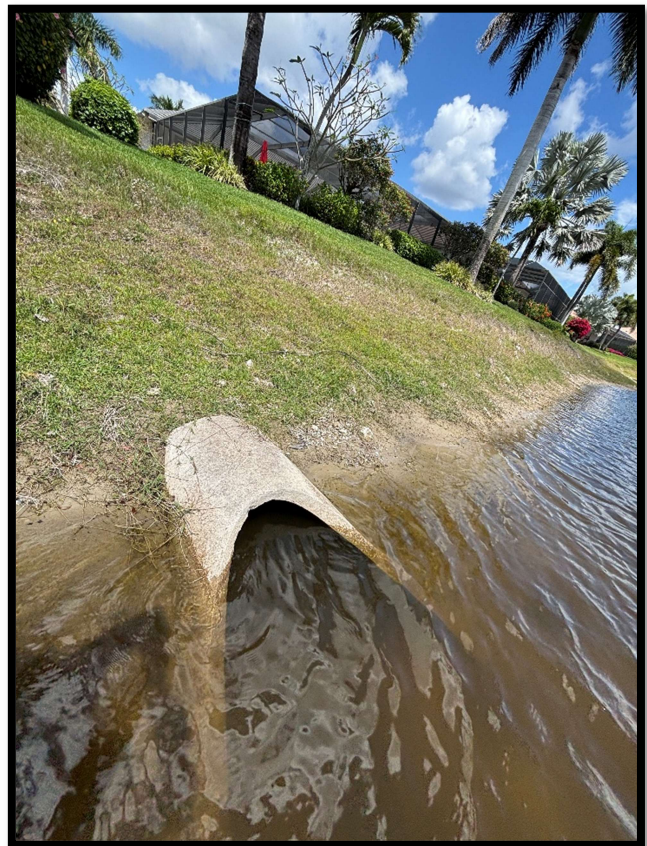
PHOTOS OF PIPE INLET 15 AND OUTLET 17 (LAKE 6L)

- The inlet box contains standing water at the bottom.
- The pipe opening is visible from the inlet, confirming connectivity to lake
- No debris accumulation or blockage observed at the waterline.
- Pipe outlet at shoreline is visible; stable conditions; and no erosion observed.

- 4.3 feet from bottom of box to top of grate.

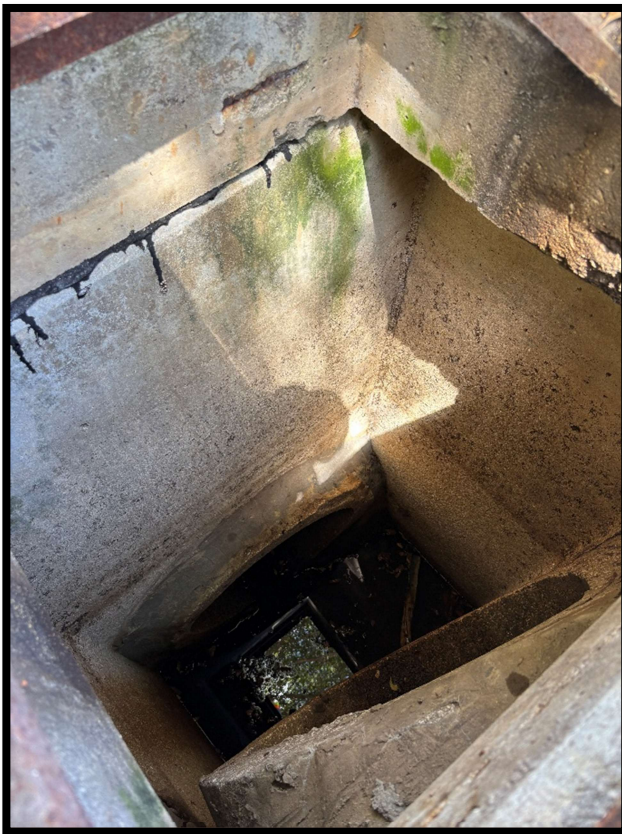
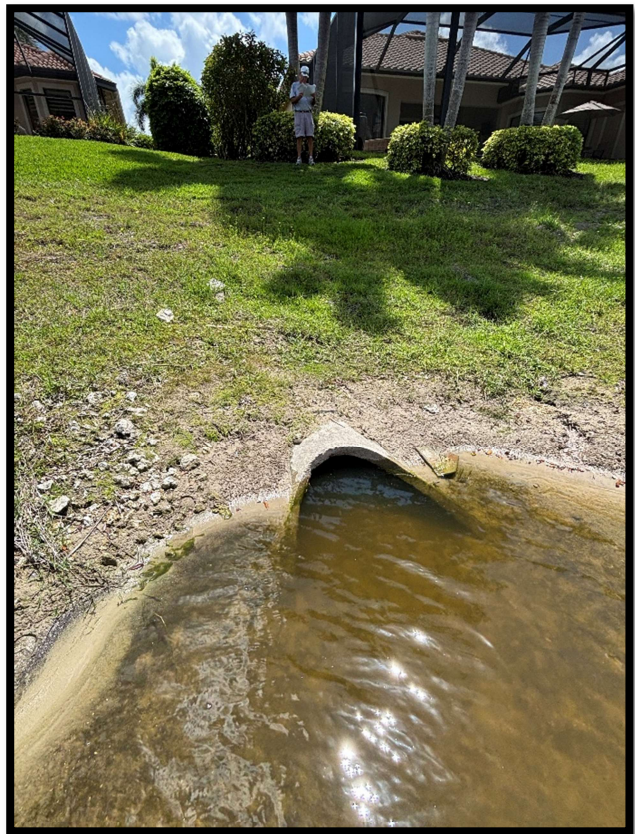
PHOTOS OF PIPE INLET 16 AND OUTLET 18 (LAKE 4L)

- The inlet box contains standing water at the bottom.
- The pipe opening is visible from the inlet, confirming connectivity to lake
- No debris accumulation or blockage observed at the waterline.
- Pipe outlet at shoreline is visible, stable conditions; and no erosion observed.

- 7 feet from bottom of box to top of grate.

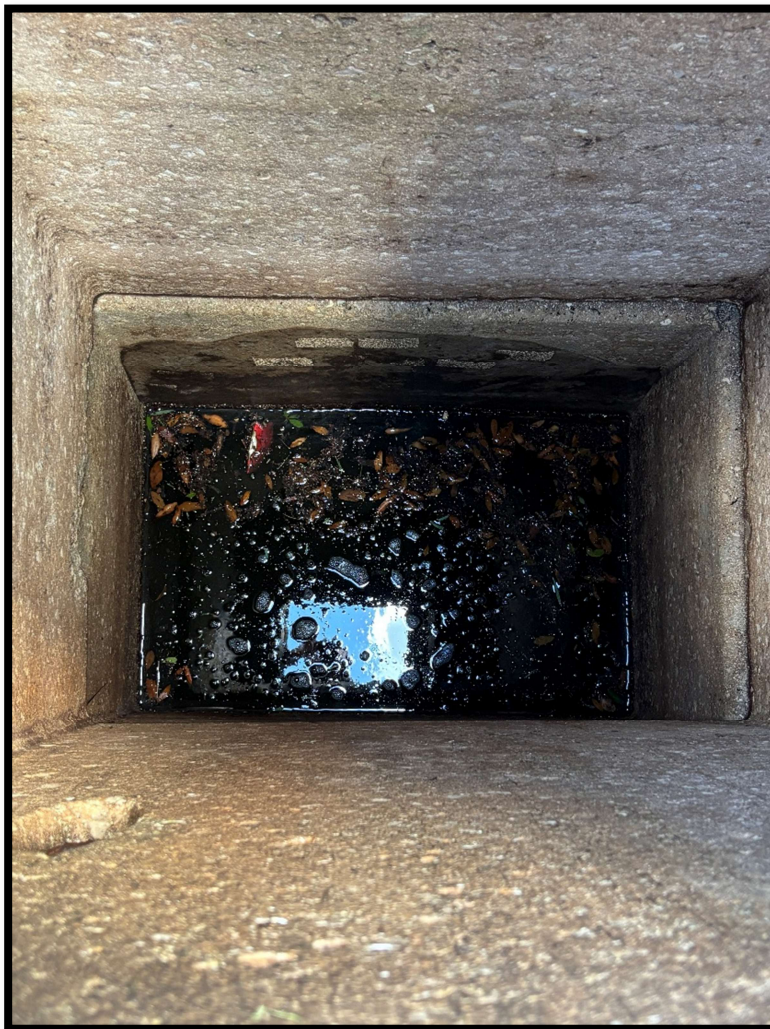
PHOTO OF PIPE INLET 42 (LAKE 5L)

- 11.2 feet from assumed silt bottom to top of grate.

1. Hire a contractor.
2. Pump water out of inlet.
3. Inspect and clean stormwater pipes, if accessible, and remove silt to restore visibility.
4. Utilize ground penetrating radar or excavate shoreline areas where pipes/outlets should be.
5. Conduct a camera inspection once pipe openings are accessible.

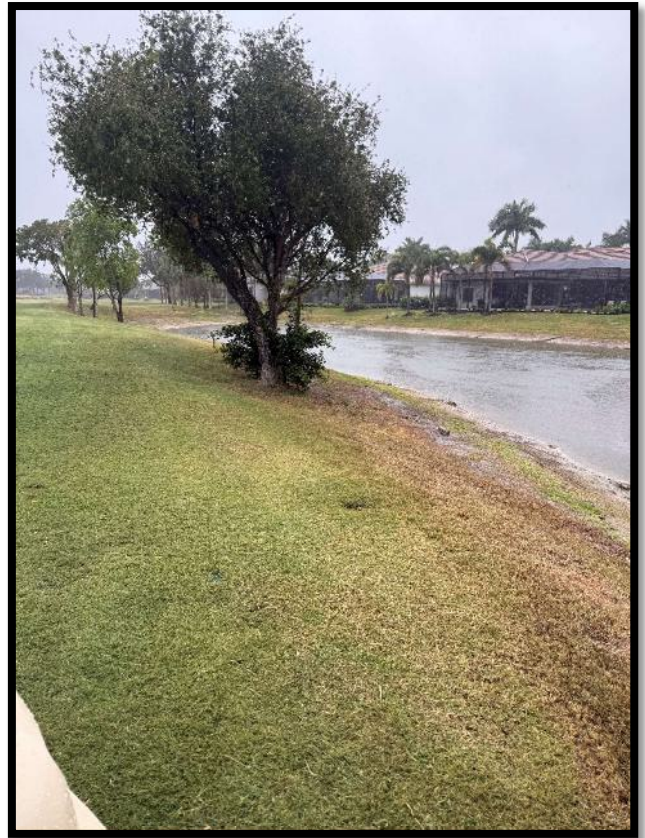
Lake 1 – Priority: 10

- 6 Washouts
- No drop-offs
- No littoral coverage

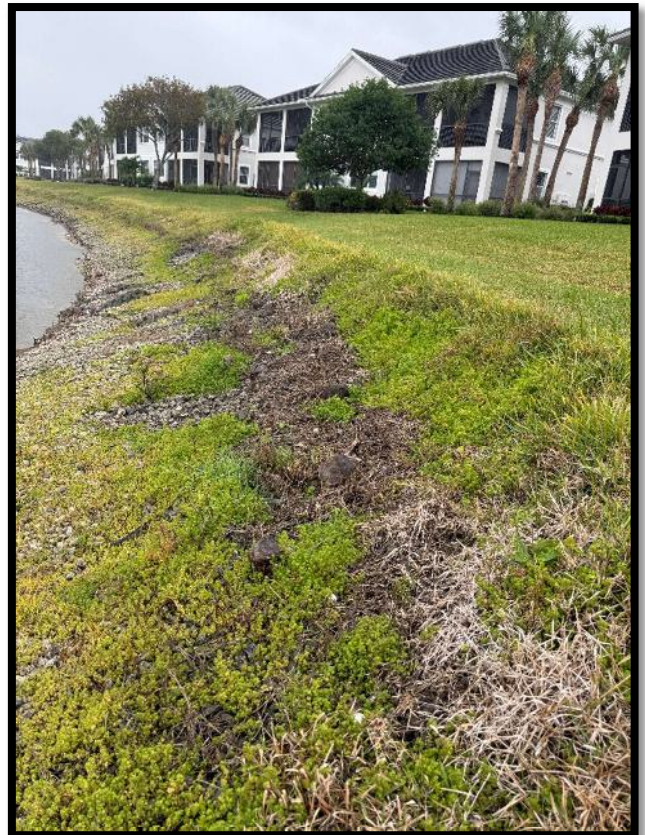
Lake 2 – Priority: 13

- 1 Washout
- < 5% of 8–12-inch drop-offs
- No littoral coverage

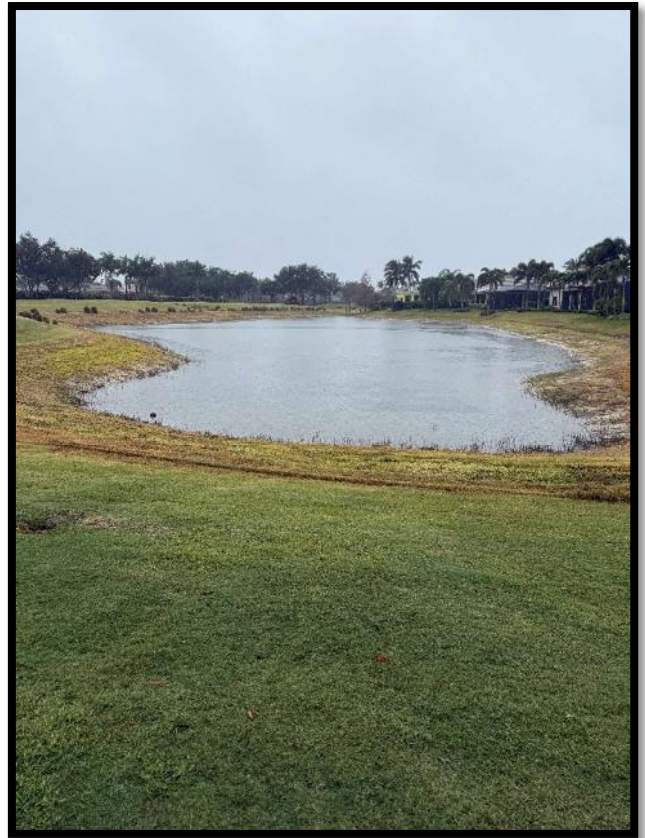
Lake 3 – Priority: 15

- 1 Washout
- No drop-offs
- 50% littoral coverage

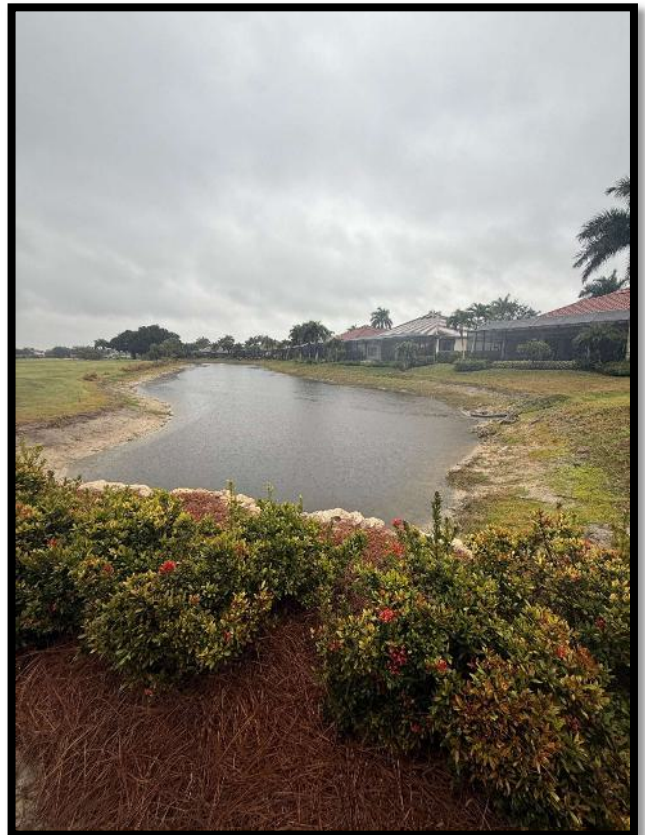
Lake 4 – Priority: 3

- 15 Washouts
- 20-30% of 12–18-inch drop-offs
- No littoral coverage

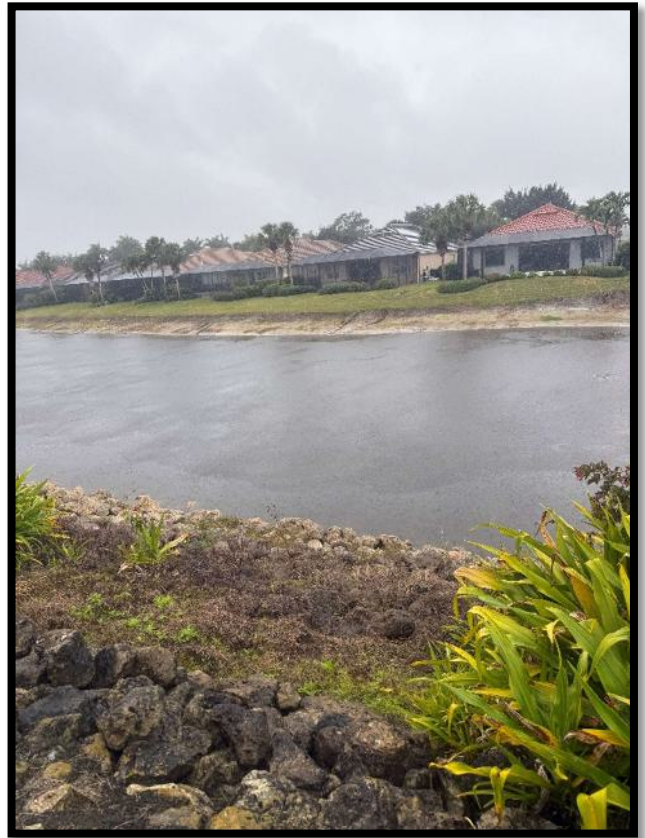
Lake 5 – Priority: 5

- 5 Washouts
- < 50% of 8–12-inch drop-offs
- No littoral coverage

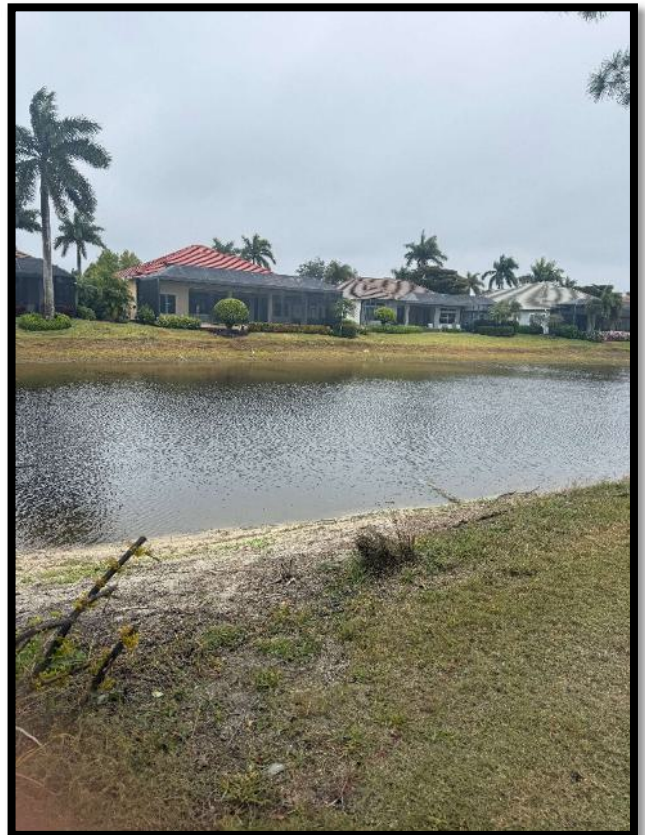
Lake 6 – Priority: 6

- 3 Washouts
- 20% of 12–18-inch drop-offs
- No littoral coverage

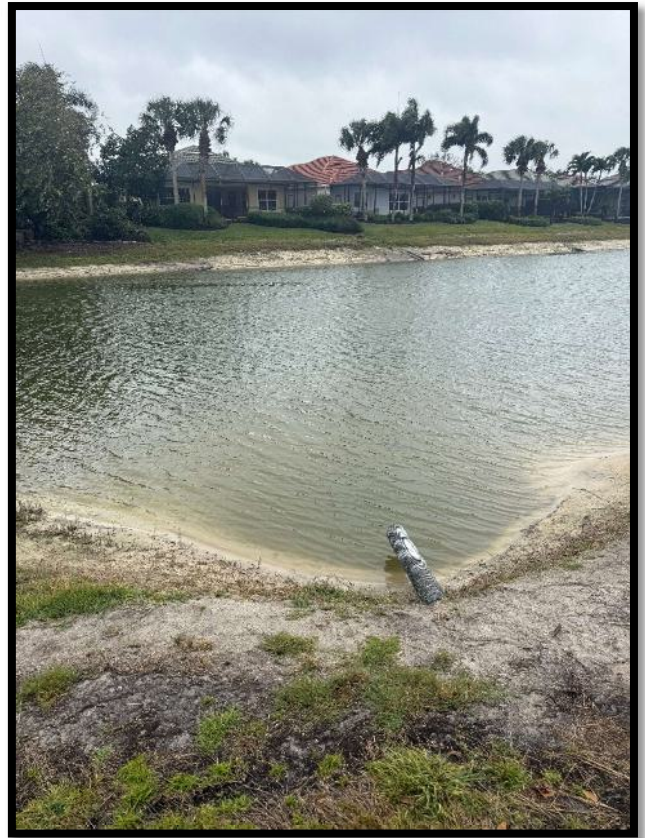
Lake 7 – Priority: 11

- 6 Washouts
- No drop-offs
- No littoral coverage

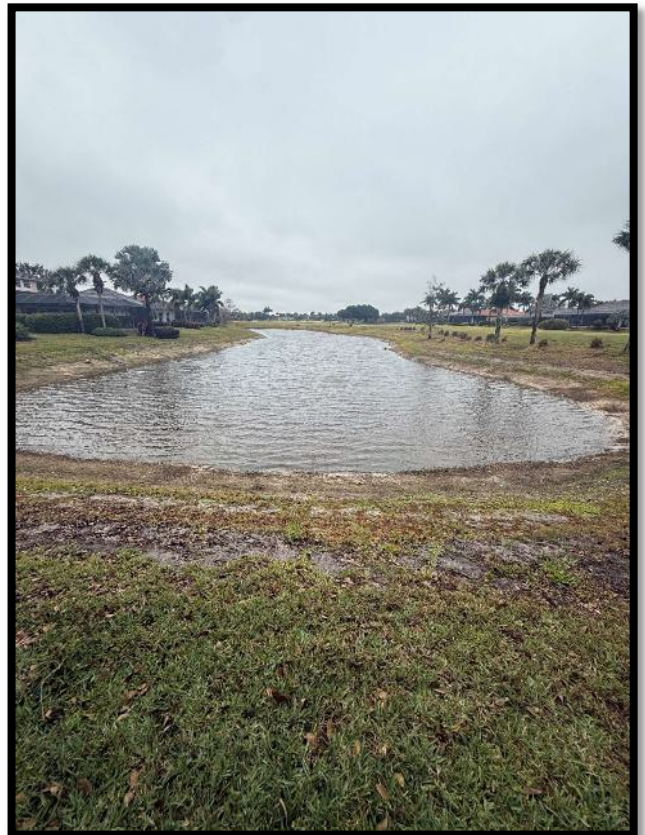
Lake 8 – Priority: 12

- 5 Washouts
- No drop-offs
- No littoral coverage

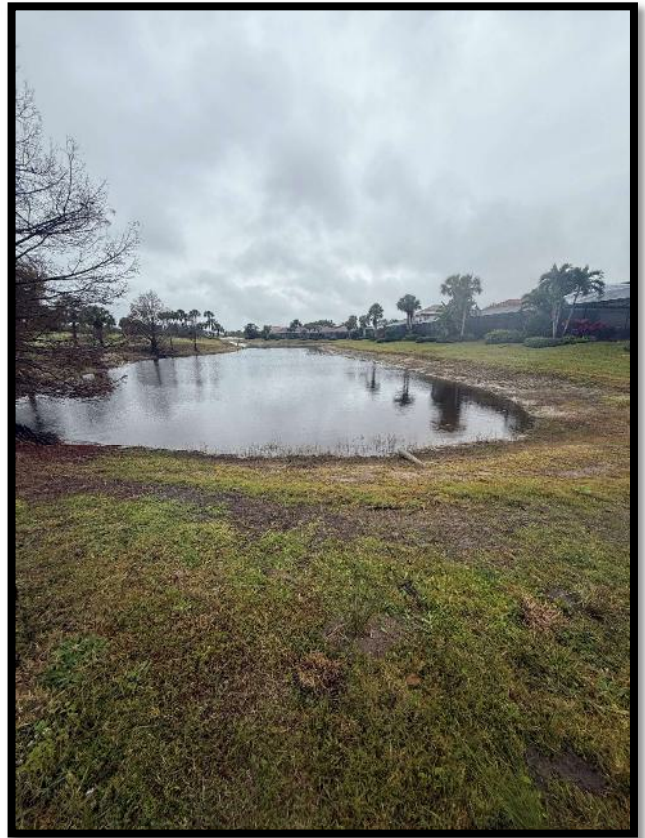
Lake 9 – Priority: 7

- 7 Washouts
- 10% of 8–12-inch drop-offs
- No littoral coverage

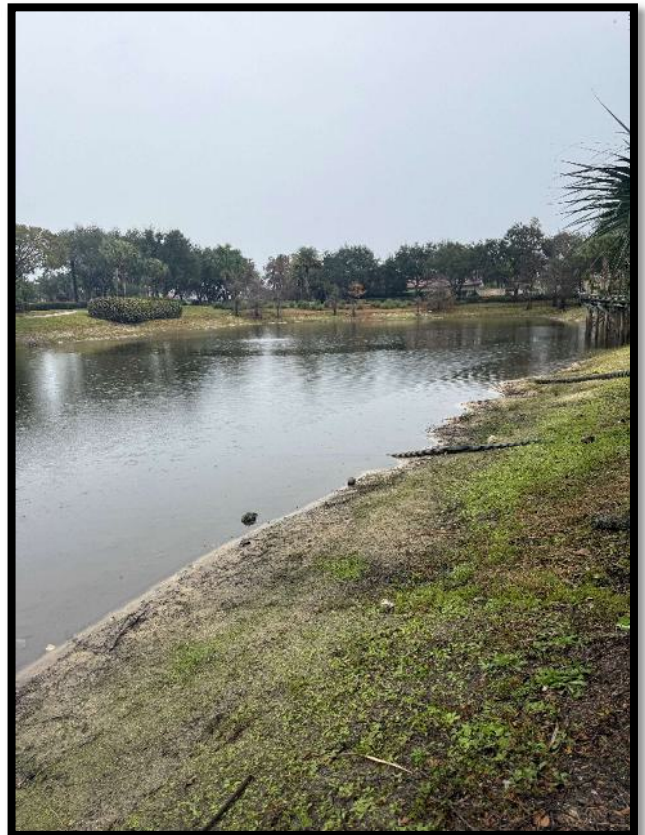
Lake 10 – Priority: 8

- 12 Washouts
- No drop-offs
- No littoral coverage

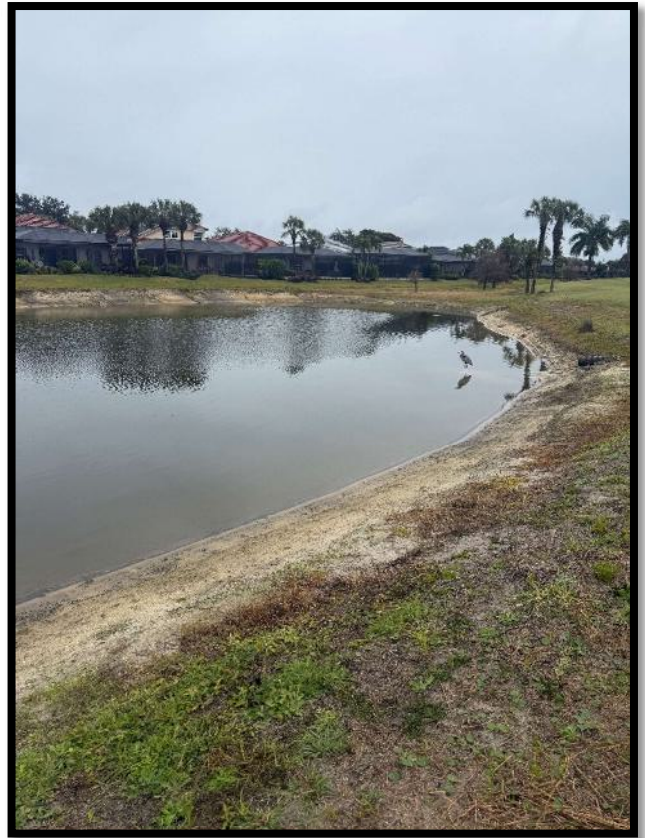
Lake 11 – Priority: 9

- 7 Washouts
- No drop-off
- No littoral coverage

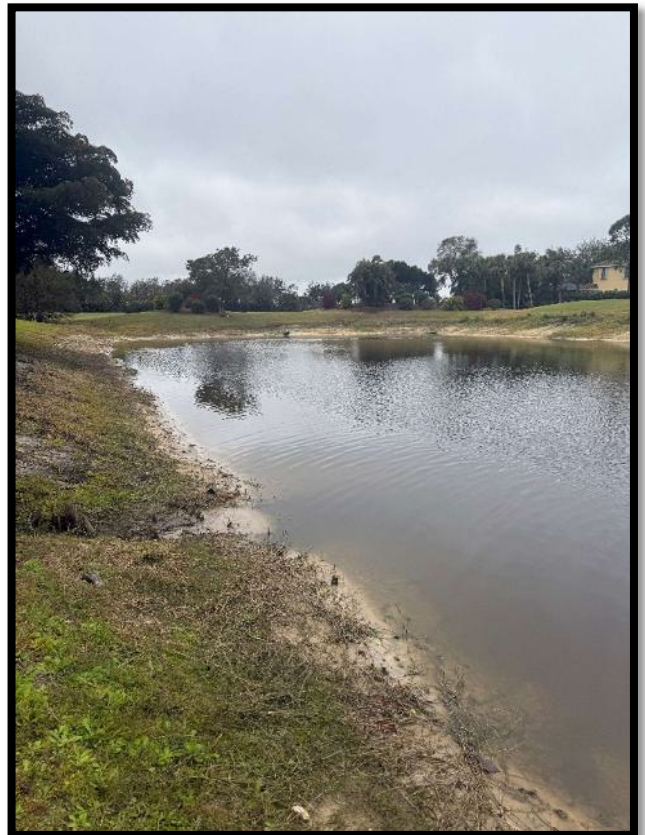
Lake 12 – Priority: 4

- 15 Washouts
- 10% of 8–12-inch drop-offs
- No littoral coverage

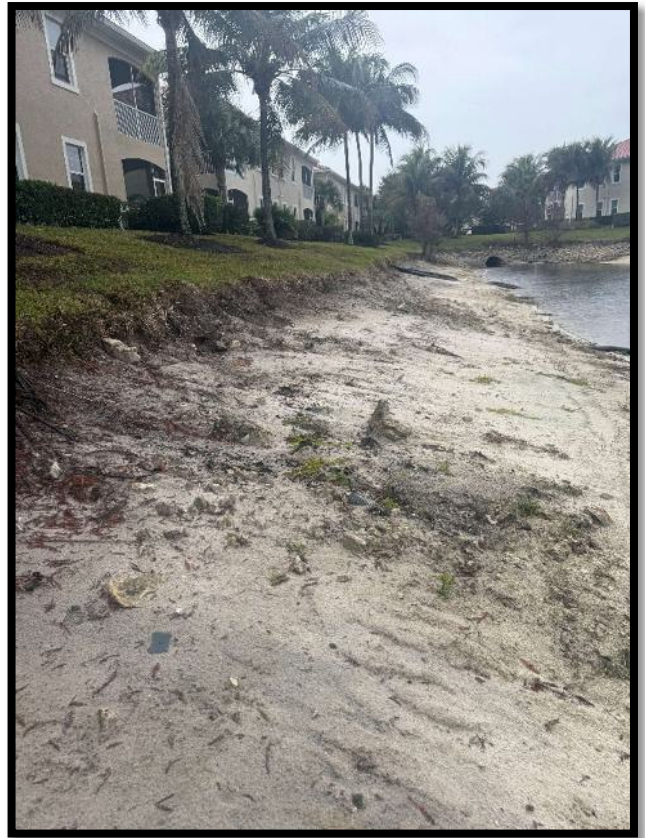
Lake 13 – Priority: 2

- 7 Washouts
- 20-30% of 12–18-inch drop-offs
- No littoral coverage

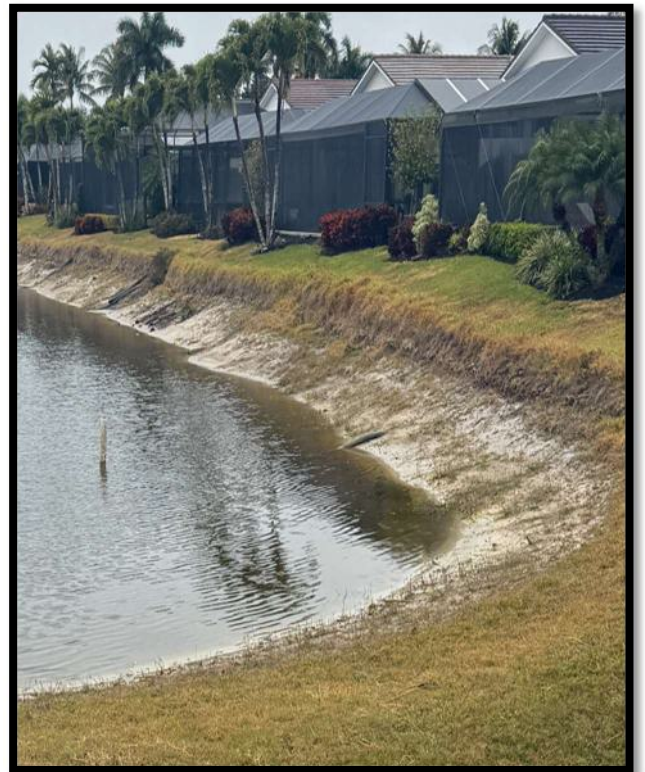
Lake 14 – Priority: 1

- 8 Washouts
- 10% of 12–18-inch drop-offs
- 30% of 24 inch or greater drop-offs
- No littoral coverage

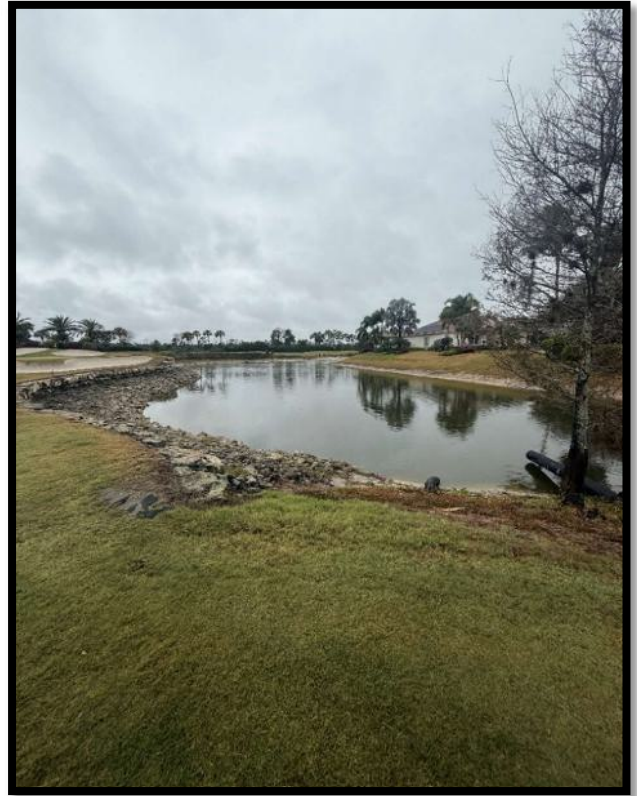
Lake 15 – Priority: 14

- 1 Washout
- No drop-offs
- No littoral coverage

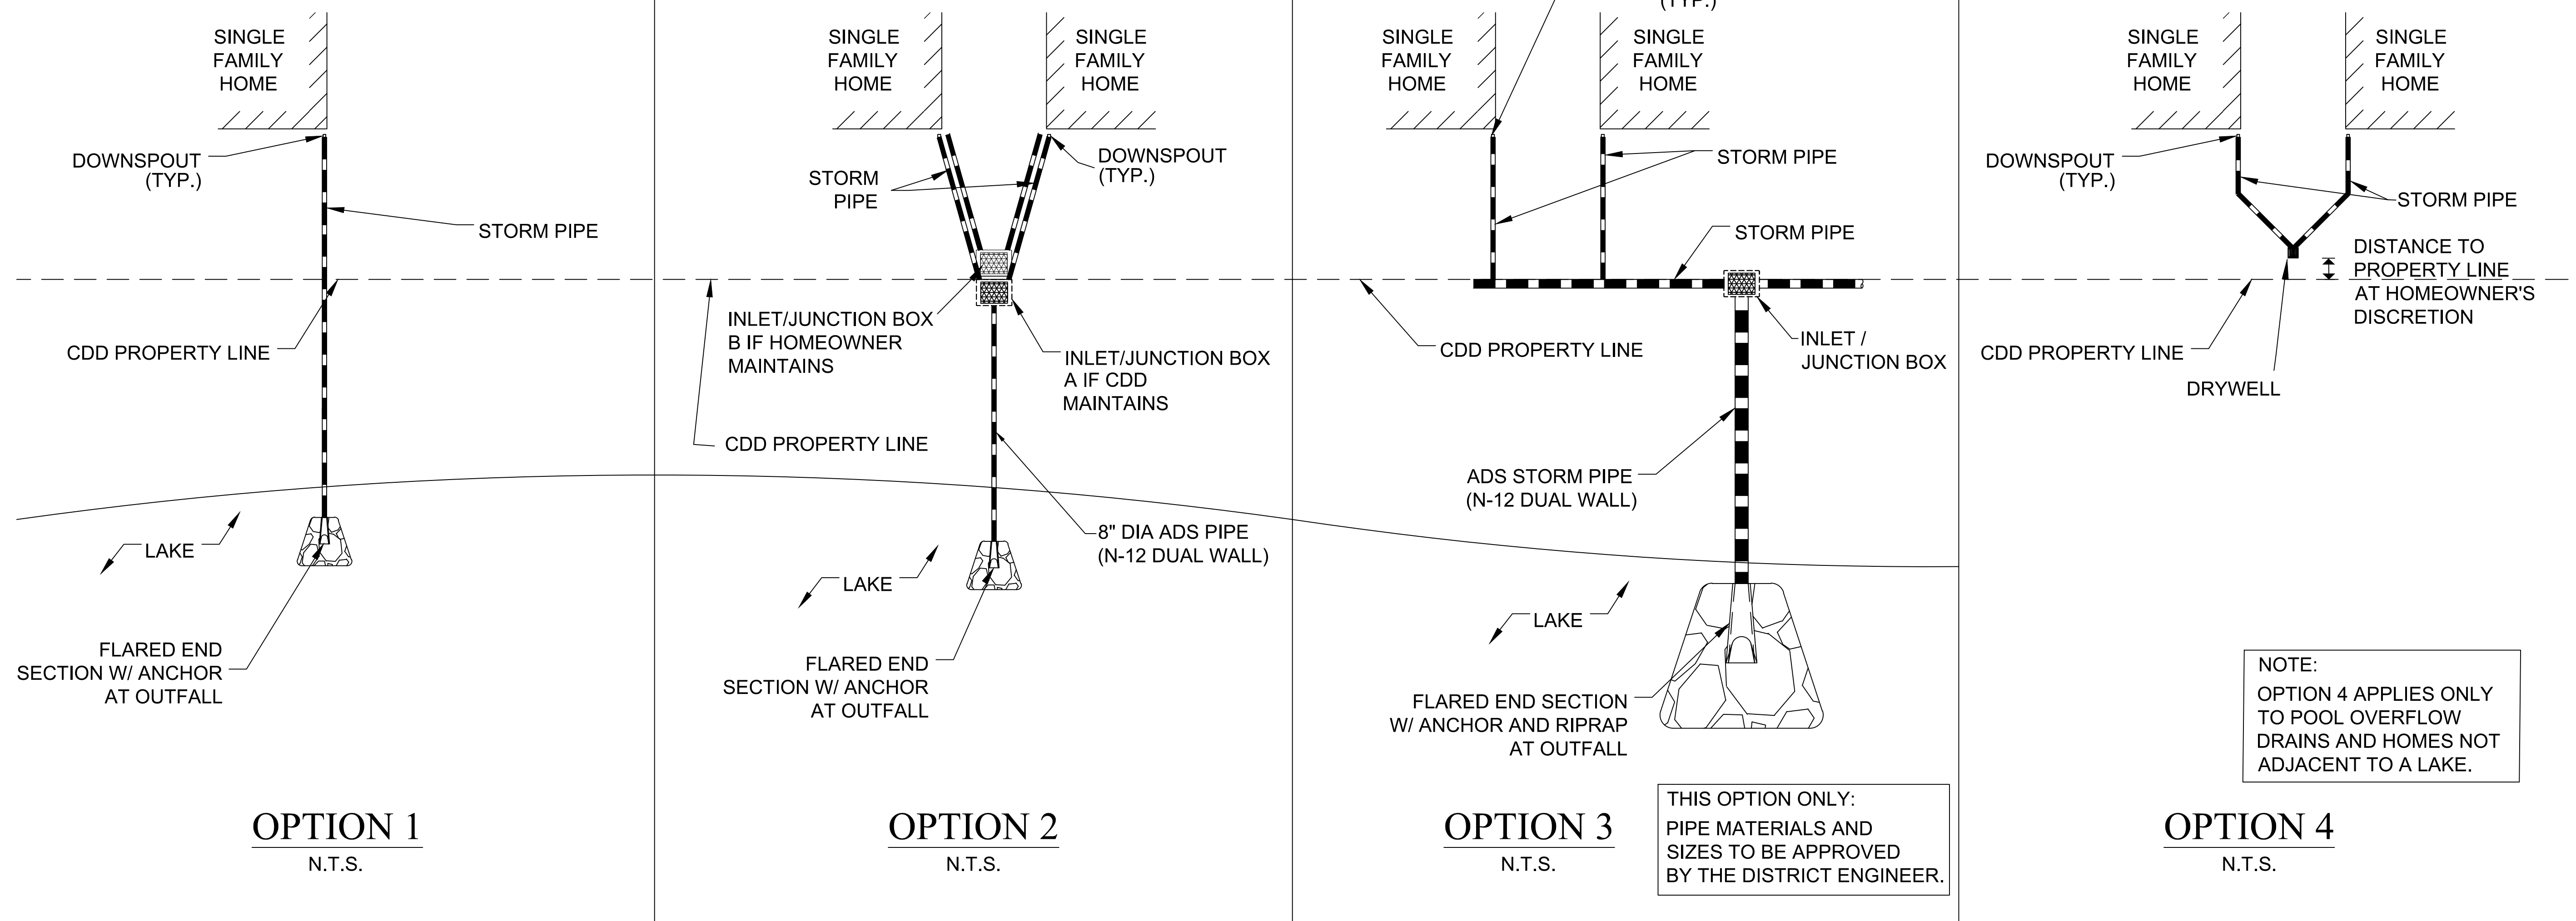
DRAIN CONNECTION DETAIL

- NOTES:**
1. PRE-APPROVED PIPE MATERIALS: POLYETHYLENE, POLYPROPYLENE, REINFORCED CONCRETE, AND PVC (SCH. 40).
 2. ALL HARDWARE SHALL BE STAINLESS STEEL.

- NOTE:**
1. INSTALL TYPE D-3 GEOTEXTILE IN ACCORDANCE WITH SPECIFICATION 514
 2. CATCH BASIN PLUG (N1206) WILL BE INSTALL ON UNUSED OUTLETS

Prior to the commencement of any lake bank restoration work, point source and washout repairs must be made to properly reinstall the drainage pipe discharges along the lake banks, see attached **Exhibit C**, “Drain Connection Detail”. While a total of ninety-nine (99) washouts were identified for repair, it is anticipated that there are more buried stormwater drainpipes that are in poor condition and may need to be replaced.

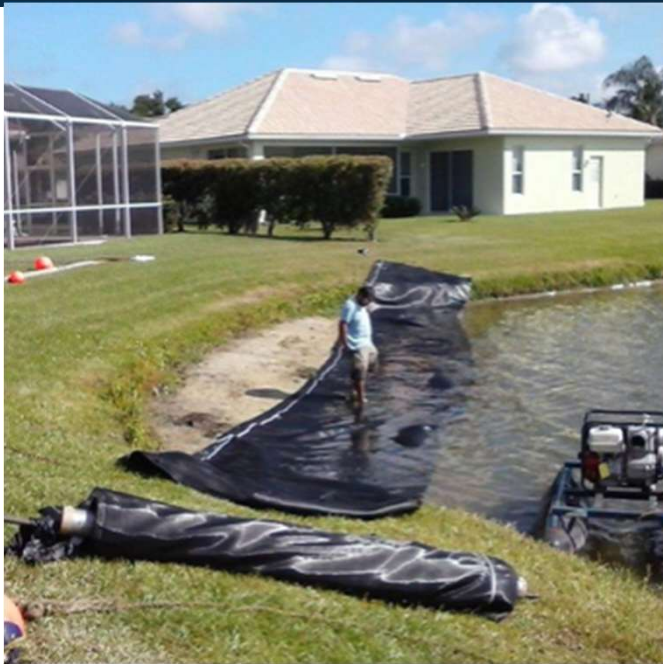
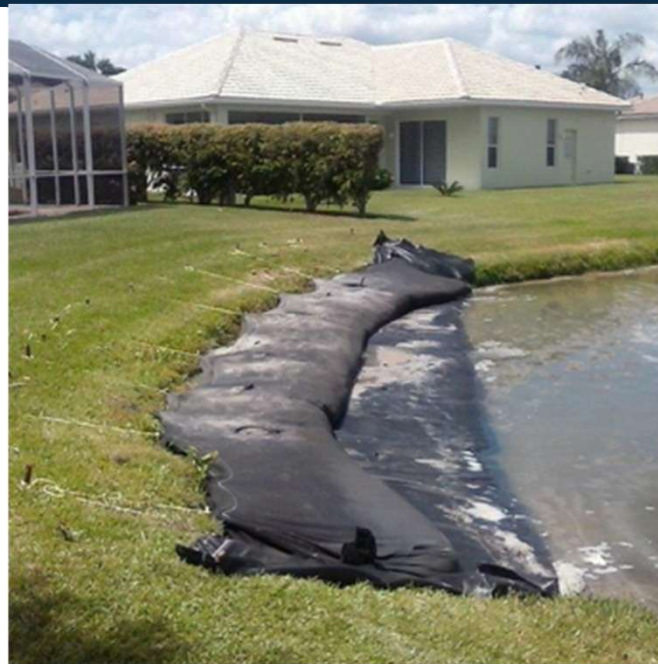
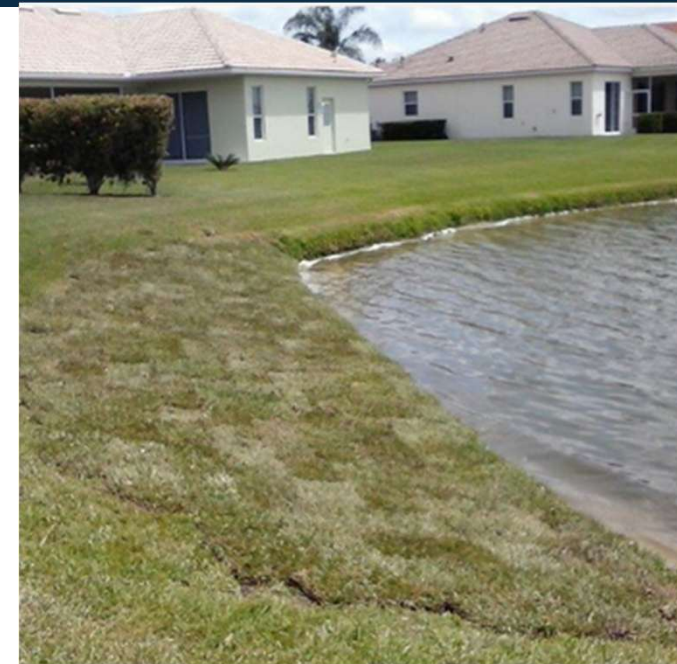
GeoSOX Installation

Filling GeoSOX with Sediment

Sodding Over GeoSOX

- Flexible, tubular geotextile containers for shoreline & bank stabilization
- Filled with soil & placed at the base of eroding banks
- Reduces wave energy & prevents soil loss
- Supports vegetation growth & natural shoreline restoration
- Provides a low-profile, environmentally friendly erosion control solution

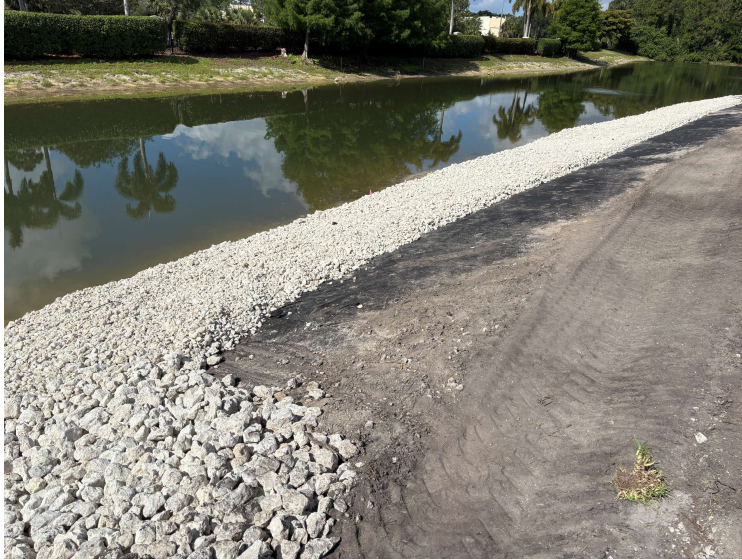
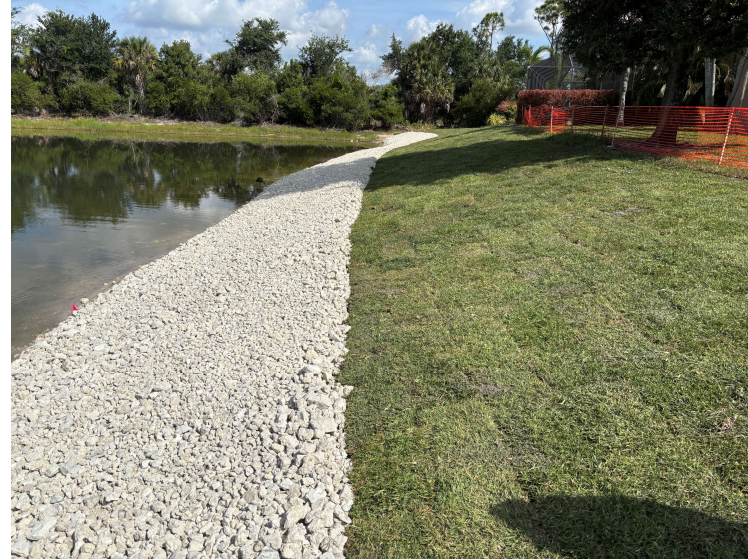
Stone Lake Bank Cover

- Uses No. 4 stone to provide immediate, high-strength stabilization
- Ideal for steep or repeatedly failing sections
- Low-maintenance, long-service-life solution
- Allows water to pass through while holding soil in place

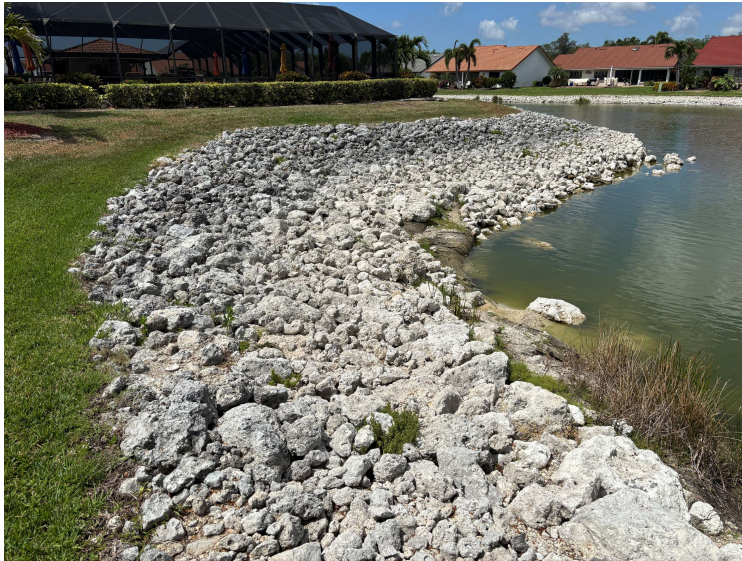
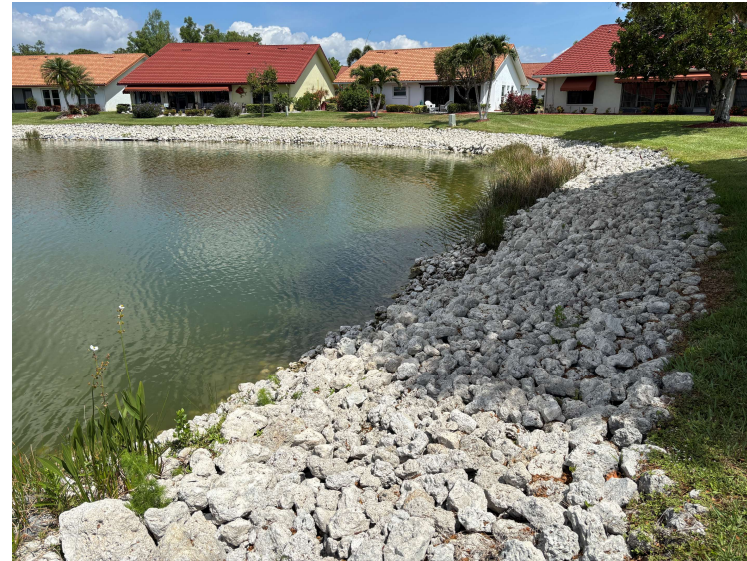
RipRap Lake Bank Cover

- Uses 6 to 12" in diameter angular rock to provide heavy-duty shoreline protection
- Placed along lake banks to stabilize shorelines & prevent erosion
- Ideal for high-energy or repeatedly failing banks
- Long-service-life, low-maintenance solution
